TEXTILE APPLICATIONS: CARDING, BEAMING, CREELS Page 1 of 2

SOLUTIONS TO STATIC PROBLEMS

STENTERS and INSPECTION Page 2 of 2

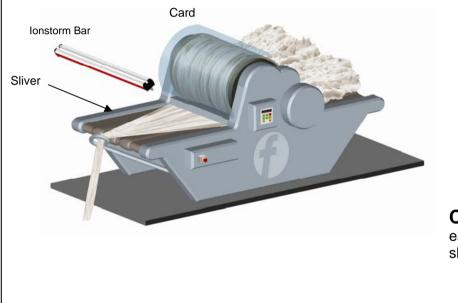
Carding

The sliver coming out of the carding process can be highly charged. The long-range lonstorm static eliminator can be positioned about 500mm above the apron so will not interfere with the product.

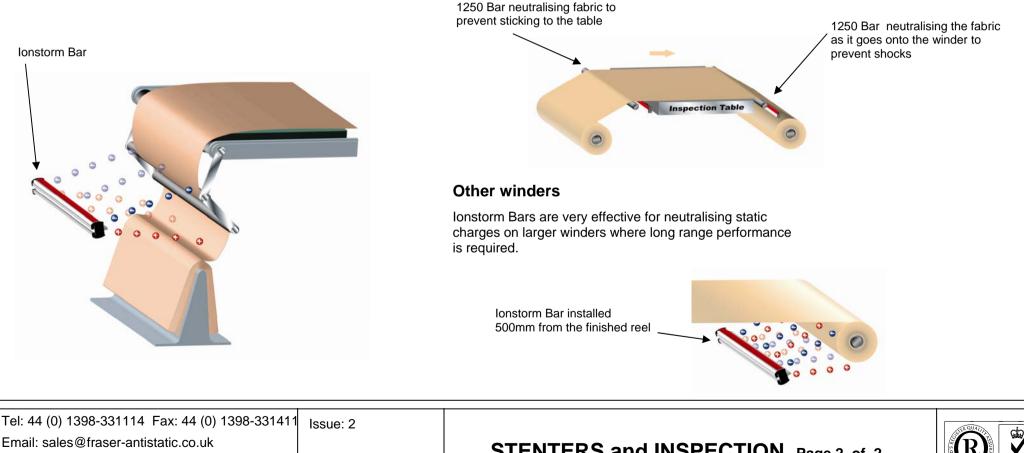
Inspection Machines

Static charge is generated as the fabric is unwound and passes over the light table.

This can cause adhesion to the table and also give shocks to people handling the inspected fabric. The solution is to position 1250 Bars as shown in the sketch below.
